# Technical Service Bulletin

## Camshaft Adjuster 3.0L - DTCs stored and/or oil leaks

15 07 01 2005587/4, Jan. 10, 2007. Supersedes Technical Service Bulletin Group 15 Number 06-05 dated Oct. 9, 2006 due to addition of DTC codes.

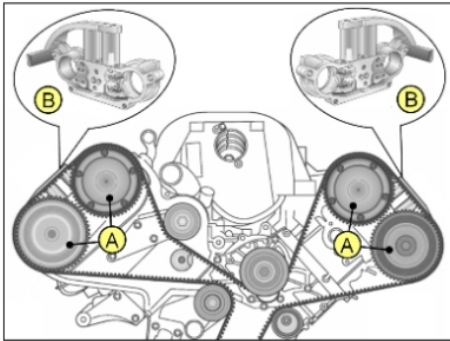
3. In case of an oil leak from a camshaft adjuster, perform the following repairs only on the affected side.

**Do not replace complete camshaft adjusters (A) or camshaft adjustment housings (B).**

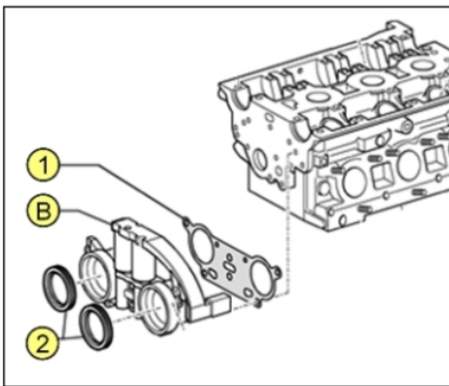
Gaskets and/or sealing rings of camshaft adjusters and/or timing case might be leaking.

- Replace gasket (1) between camshaft adjustment housing (B) and cylinder head.
- Replace both camshaft sealing rings (2) (See Repair Manual, Group 15, "Camshaft and camshaft adjusters, removing and installing")

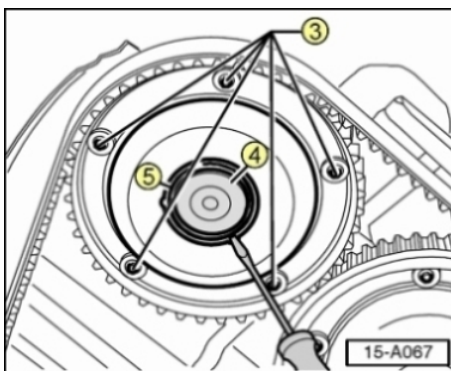
The internal bolts of camshaft adjuster(s) might have a reduced torque.

- Retorque all five outer bolts (3) on all four camshaft adjusters to 15 Nm. (The bolt heads are located on the back side of the camshaft adjuster gears.)
- Replace missing or damaged bolts (part number WHT 003 121).
- Replace caps (4) and O-Rings (5) and secure with securing ring (See Repair Manual, Group 15, "Camshaft and camshaft adjusters, removing and installing")
- Reassemble removed components and complete the repair.
