**Technical Service
BULLETIN**

U660E SHIFT FLARE CONCERNS

'07 Camry (V6)

TC007-07

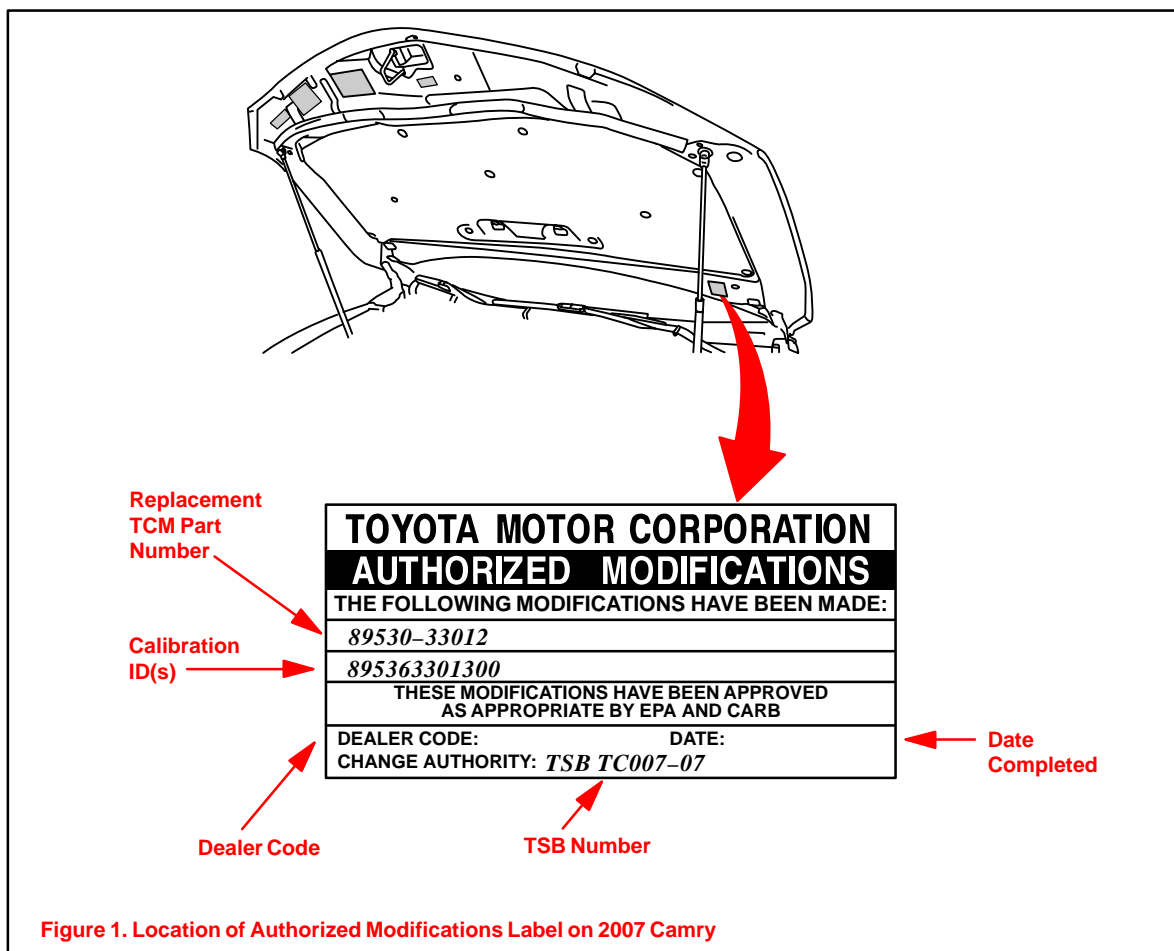
1. Check for the Authorized Modifications Label affixed to the vehicle in the location shown in Figure 1. Confirm if the TCM calibration has been updated. If the calibration ID listed is NOT the latest TCM calibration — go to step 2.

- B. Affix the Authorized Modifications Label to the vehicle at the location shown in Figure 1. The Authorized Modifications Label is available through the MDC, P/N 00451–00001–LBL.
