**Technical Service
BULLETIN**

**ENGINE OIL DRIP: BANK 1
VVTi OIL LINE**

'05 Avalon

**ENGINE
EG064-05**

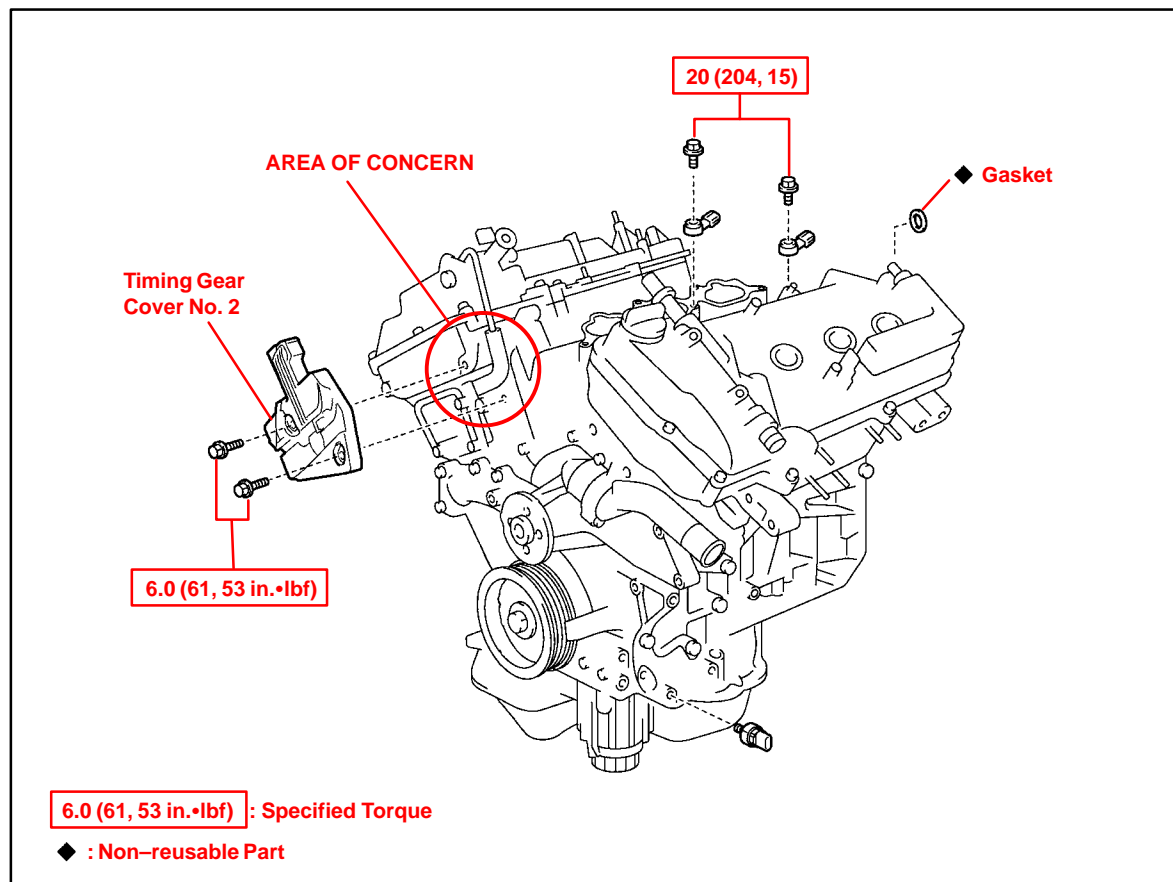
1. Confirm that the source of the oil drip is from the oil pipe sub-assembly for bank 1 VVTi in the area indicated in the illustration below.

The oil drip is occurring under timing gear cover No. 2 where the rubber hose connects to the metal pipe, with some oil held in the insulating foam.

2. If the pipe/hose connection is NOT leaking, continue leak source identification using a leak identification marking dye.
3. If the oil pipe sub-assembly on bank 1 of the engine is leaking, replace the oil pipe.
 - A. Remove timing gear cover No. 2.
